**Flood Control Project Maintenance
Levee Inspections**
LMA District Cover Sheet
Spring 2019 Levee Inspection Results

Sutter Maintenance Yard East Levee Sacramento River

Spring 2019 Levee Inspection Results

Levee Inspection Report By Mile - Spring 2019

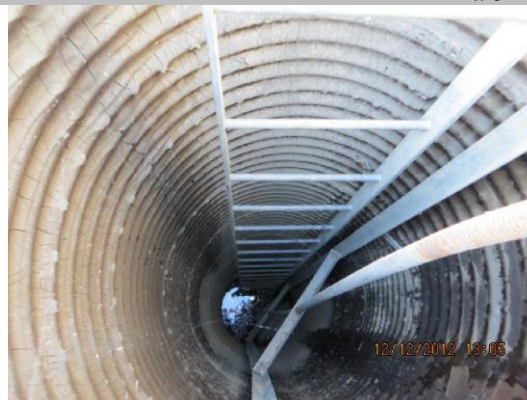
Photo 2 of 3 : UCIP_SP_2019_51688_47156.jpg

Comment Code						
Inspector Comment						
FS_ID:51688 DS_ID:17306 EP_NO: 9530 Repair Type: Non-Urgent Crossing Status: Found UCIP Comments: 4/16/2017 Abandoned- needs to be done properly. (DWR Sutter Yard- AFreitag)10/31/2016 Appears abandoned. (DWR Sutter Yard- AFreitag)6/1/2016 Appears to be an abandoned crossing. WS end is about 90% buried with soil and the LS end is still unknown.4/1/2015 WS pipe end 3/4 blocked by soil. LS end is still unknown.Pipe outlet on WS partially burried, it needs cleaning.6/30/2014 Same as last inspection.12/18/2013 Same as last inspection.7/23/2013 Same as last inspection FIELD_STRUCT_DESC: *ABANDONED* 30-inch corrugated metal drainage pipe through the levee, 15 feet below the crown. Slide gate in a corrugated metal pipe (CMP) riser on the waterside (WS) slope. (30-inch pipe [HLM 6.37] authorized under Automatic Board Order (ABO) issued as Permit No. 9530, 1974 - Halsey). [Additional Reference(s): DWR Levee Log, 2002]. FS Date: 4/26/2017 1:45:14 PM

Waterside view: inside CMP riser

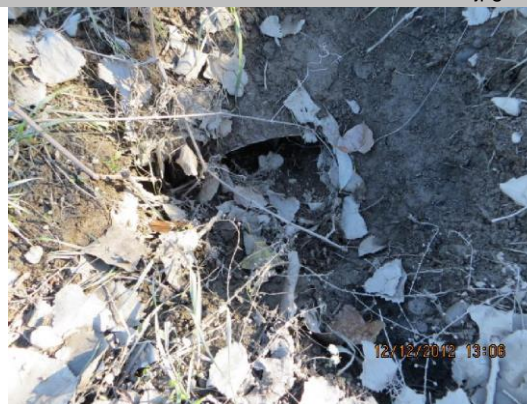
Photo 3 of 3 : UCIP_SP_2019_51688_47157.jpg

Waterside view: partially buried steel pipe

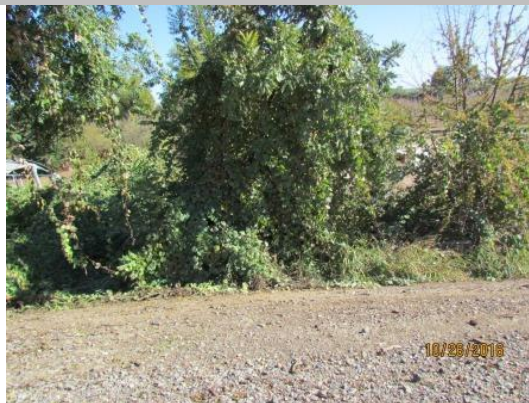
Photo 1 of 1 : SP_2019_ST0003_264_99_20190327_00024.jpg

LM Start	6.47	Rating **	M	Issue No.	99
LM End	6.47	Issue Type +	Ma	Location *	LS
Category	Earthen Levee			GPS Latitude/Longitude	
				Start	End
Item	Vegetation			39.224719 °	39.224719 °
				-121.998623 °	-121.998623 °
DWR ID	DWR_ST0003_01_f_2016_99				
Comment Code					
V2 : Remove the wild growth other than native grasses from the levee slopes.					
Inspector Comment

View of the overgrown vegetation along the landside slope.

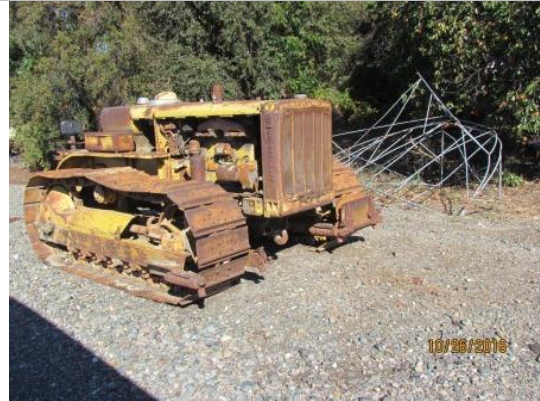
Photo 1 of 1 : SP_2019_ST0003_264_98_20190327_00023.jpg

LM Start	6.51	Rating **	M	Issue No.	98
LM End	6.51	Issue Type +	En	Location *	LS
Category	Earthen Levee			GPS Latitude/Longitude	
				Start	End
Item	Encroachments			39.225307 °	39.225307 °
				-121.998755 °	-121.998755 °
DWR ID	DWR_ST0003_01_f_2016_98				
Comment Code					
EQ : Equipment					
Inspector Comment					
The equipment should be removed from the landside shoulder.

View of the ag equipment along the landside toe.

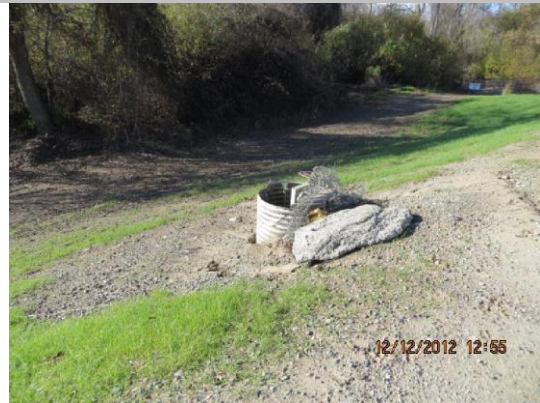
Photo 1 of 2 : UCIP_SP_2019_51689_47181.jpg

Comment Code					
Inspector Comment					
FS_ID:51689 DS_ID:17296 EP_NO: 9530 Repair Type: Non-Urgent Crossing Status: Indicator Found UCIP Comments: 4/19/2017 Abandoned- needs to be done properly. (DWR Sutter Yard- AFreitag)10/31/2016 Abandoned. (DWR Sutter Yard- AFreitag)6/1/2016 Abandoned- only WS riser and screwgate found.4/1/2015 Only cmp riser with screwgate found on WS. Screwgate stem is bent.Appears abandoned and should be verified as having been done so properly. Only CMP riser with slide gate found on WS6/30/2014 Same as last inspection.12/18/2013 Same as last inspection.7/23/2013 Same as last inspection FIELD_STRUCT_DESC: *ABANDONED* 24-inch corrugated metal drainage pipe through the levee, 13.5 feet below the crown, not found in 2015. Slide gate in a corrugated metal pipe (CMP) riser on the waterside (WS) slope, found in 2015. (24-inch pipe [HLM 6.61] authorized under Automatic Board Order (ABO) issued as Permit No. 9530, 1974 - Halsey). [Additional Reference(s): DWR Levee Log, 2002. USACE Sacramento O&M Manual 136, March 1960 (HLM 6.61)]. FS Date: 4/26/2017 1:50:06 PM

Waterside view: CMP riser with slide gate

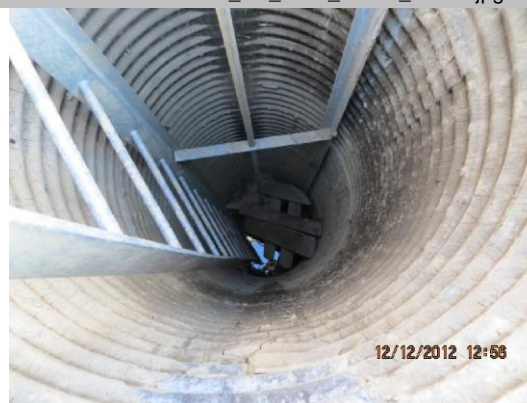
Photo 2 of 2 : UCIP_SP_2019_51689_47180.jpg

Comment Code						
Inspector Comment						
FS_ID:51689 DS_ID:17296 EP_NO: 9530 Repair Type: Non-Urgent Crossing Status: Indicator Found UCIP Comments: 4/19/2017 Abandoned- needs to be done properly. UCIP Sutter Yard- AFreitag)10/31/2016 Abandoned. (DWR Sutter Yard- AFreitag)6/1/2016 Abandoned- only WS riser and screwgate found.4/1/2015 Only cmp riser with screwgate found on WS. Screwgate stem is bent.Appears abandoned and should be verified as having been done so properly. Only CMP riser with slide gate found on WS6/30/2014 Same as last inspection.12/18/2013 Same as last inspection.7/23/2013 Same as last inspection FIELD_STRUCT_DESC: *ABANDONED* 24-inch corrugated metal drainage pipe through the levee, 13.5 feet below the crown, not found in 2015. Slide gate in a corrugated metal pipe (CMP) riser on the waterside (WS) slope, found in 2015. (24-inch pipe [HLM 6.61] authorized under Automatic Board Order (ABO) issued as Permit No. 9530, 1974 - Halsey). [Additional Reference(s): DWR Levee Log, 2002. USACE Sacramento O&M Manual 136, March 1960 (HLM 6.61)]. FS Date: 4/26/2017 1:50:06 PM

Waterside view: inside CMP riser

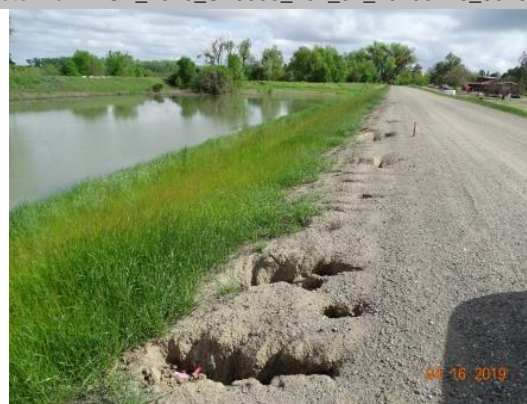
Photo 1 of 1 : SP_2019_ST0003_264_97_20190418_00190.jpg

LM Start	6.75	Rating **	M	Issue No.	97
LM End	6.75	Issue Type +	Ma	Location *	WS
Category	Earthen Levee			GPS Latitude/Longitude	
				Start	End
Item	Slope Stability			39.228291 °	39.228291 °
				-121.998579 °	-121.998579 °
DWR ID	DWR_ST0003_01_f_2016_97				
Comment Code					
S1 : Repair slope instability.					
Inspector Comment

View of rodent activity, erosion and caving on the waterside slope and shoulder. Spring 2019.

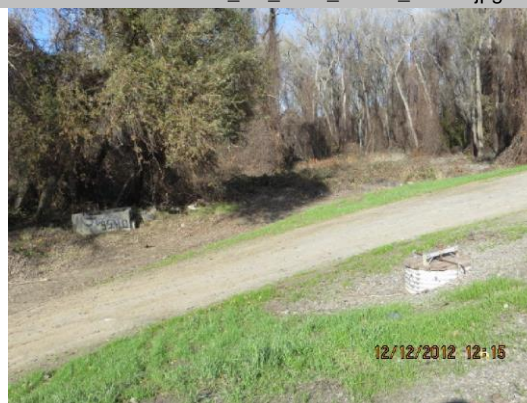
Photo 1 of 3 : UCIP_SP_2019_51694_47189.jpg

Comment Code					
Inspector Comment					
FS_ID:51694 DS_ID:17300 EP_NO: N/A Repair Type: Non-Urgent Crossing Status: Indicator Found UCIP Comments: 4/19/2017 Abandoned- needs to be done properly. (DWR Sutter Yard- AFreitag)10/31/2016 Abandoned (DWR Sutter Yard- AFreitag)6/1/2016 Abandoned4/1/2015 Only cmp riser and slide gate found on WS.Abandoned riser with slide gate on WS. Abandoned concrete surge box on WS. Verify pipe has been abandoned properly. 6/30/2014 Same as last inspection.12/18/2013 Same as last inspection.7/23/2013 Same as last inspection. FIELD_STRUCT_DESC: *ABANDONED* 24-inch corrugated metal drainage pipe through the levee, 14.5 feet below the crown, not found in 2015. Slide gate in a concrete surge box on the waterside (WS) berm, found in 2015. Slide gate in a corrugated metal pipe (CMP) riser, found in 2015. Pump on the WS slope, not found in 2015. [Additional Reference(s): DWR Levee Log, 2002. USACE Sacramento O&M Manual 136, March 1960 (HLM 7.61)]. FS Date: 4/26/2017 2:37:43 PM

Waterside view: overview

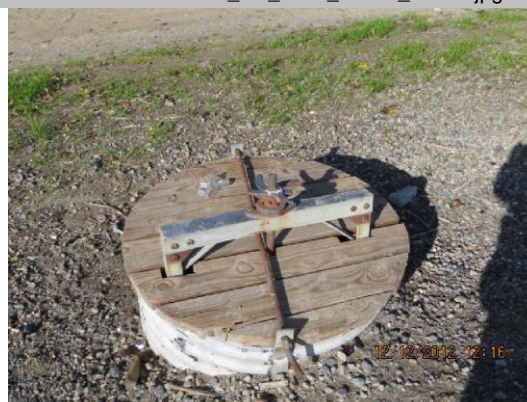
Photo 2 of 3 : UCIP_SP_2019_51694_47188.jpg

Waterside view: CMP riser with slide gate

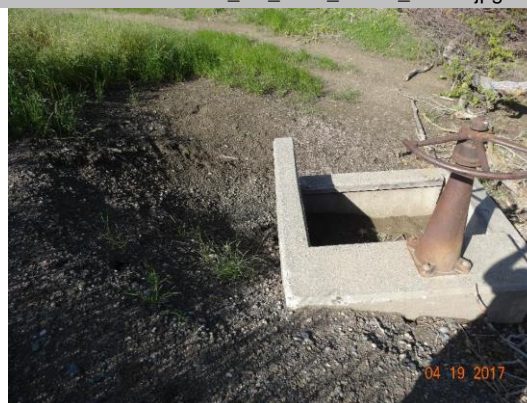
Photo 1 of 3 : UCIP_SP_2019_51695_77008.jpg

Comment Code					
Inspector Comment					
FS_ID:51695 DS_ID:17301 EP_NO: 9532 Repair Type: Non-Urgent Crossing Status: Found UCIP Comments: 4/19/2017 Abandoned- erosion/depression present around the WS box (DWR Sutter Yard- AFreitag)10/31/2016 Abandoned and erosion still present near WS box.(DWR Sutter Yard-Afreitag)6/1/2016 Appears to be an abandoned crossing.4/1/2015 Silted concrete box on WS. Depression/erosion around concrete box on WS.Silted concrete box on WS. Depression/erosion around concrete box on WS.6/30/2014 Same as last inspection.12/18/2013 Same as last inspection.7/23/2013 Same as last inspection. FIELD_STRUCT_DESC: *ABANDONED* 36-inch by 48-inch reinforced concrete box drainage culvert through the levee, 11.6 feet below the crown. Slide gate in a concrete box on the waterside (WS) slope. (3-foot by 4-foot culvert [HLM 7.73] authorized under Automatic Board Order (ABO) issued as Permit No. 9532, 1974 - Martin). [Additional Reference(s): DWR Levee Log, 2002. USACE Sacramento O&M Manual 136, March 1960 (HLM 7.73)]. FS Date: 4/26/2017 2:38:29 PM

Depression around WS concrete box

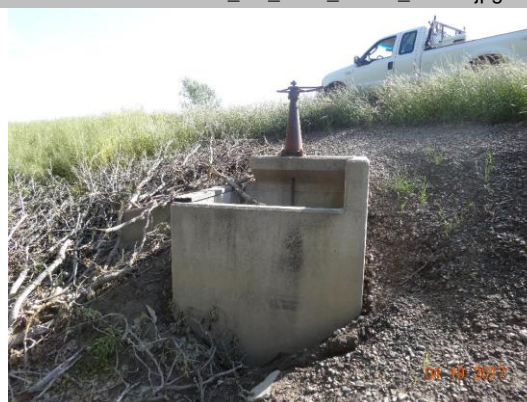
Photo 2 of 3 : UCIP_SP_2019_51695_77009.jpg

depression around WS concrete box

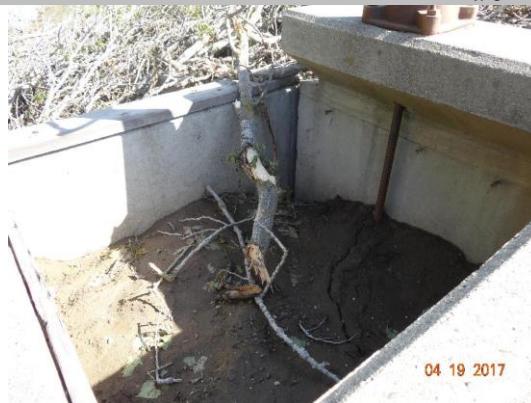
Photo 3 of 3 : UCIP_SP_2019_51695_77010.jpg

Comment Code						
Inspector Comment						
FS_ID:51695 DS_ID:17301 EP_NO: 9532 Repair Type: Non-Urgent Crossing Status: Found UCIP Comments: 4/19/2017 Abandoned- erosion/depression present around the WS box (DWR Sutter Yard- AFreitag)10/31/2016 Abandoned and erosion still present near WS box.(DWR Sutter Yard- AFreitag)6/1/2016 Appears to be an abandoned crossing.4/1/2015 Silted concrete box on WS. Depression/erosion around concrete box on WS.Silted concrete box on WS. Depression/erosion around concrete box on WS.6/30/2014 Same as last inspection.12/18/2013 Same as last inspection.7/23/2013 Same as last inspection. FIELD_STRUCT_DESC: *ABANDONED* 36-inch by 48-inch reinforced concrete box drainage culvert through the levee, 11.6 feet below the crown. Slide gate in a concrete box on the waterside (WS) slope. (3-foot by 4-foot culvert [HLM 7.73] authorized under Automatic Board Order (ABO) issued as Permit No. 9532, 1974 - Martin). [Additional Reference(s): DWR Levee Log, 2002. USACE Sacramento O&M Manual 136, March 1960 (HLM 7.73)]. FS Date: 4/26/2017 2:38:29 PM

WS concrete box full of silt.

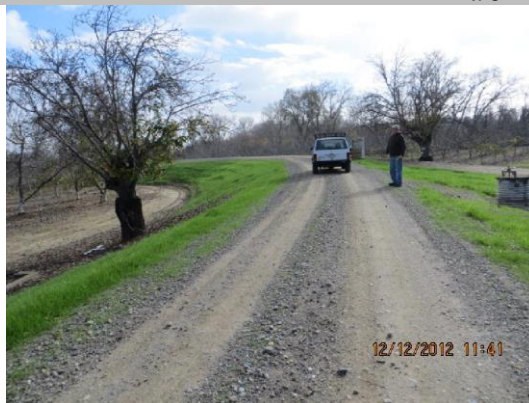
Photo 1 of 3 : UCIP_SP_2019_51698_47202.jpg

Comment Code					
Inspector Comment					
FS_ID:51698 DS_ID:17304 EP_NO: 9529 Repair Type: Non-Urgent Crossing Status: Found UCIP Comments: 4/19/2017 Abandoned- needs to be done properly. (DWR Sutter Yard- AFreitag)10/31/2016 Abandoned (DWR Sutter Yard- AFreitag)6/1/2016 Abandoned- only WS riser and slide gate found.4/1/2015 CMP riser and slide gate on WS. LS distribution box is silted in. Looks abandoned. CMP riser with slide gate on WS. Concrete distribution box on LS- full with silt.6/30/2014 Same as last inspection.12/18/2013 Same as last inspection.7/23/2013 Same as last inspection. FIELD_STRUCT_DESC: *ABANDONED* 24-inch corrugated metal drainage pipe through the levee, invert 12.8 feet below the crown. Slide gate in a corrugated metal pipe (CMP) riser on the waterside (WS) slope. Concrete box at the landside (LS) toe. (24-inch pipe [HLM 8.35] authorized under Automatic Board Order (ABO) issued as Permit No. 9529, 1974 - Dorwood Ranching Company). [Additional Reference(s): DWR Levee Log, 2002. USACE Sacramento O&M Manual 136, March 1960 (HLM 8.35)]. FS Date: 4/26/2017 2:54:54 PM

Crown view: overview (both sides of the levee)

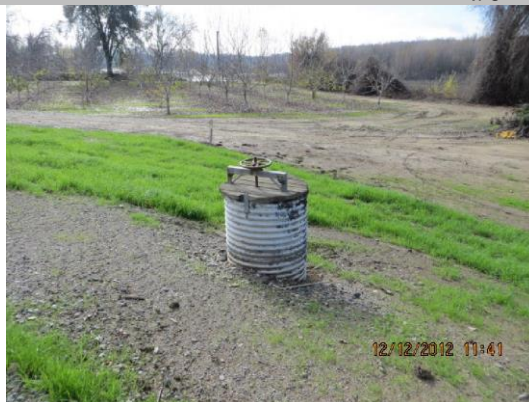
Photo 2 of 3 : UCIP_SP_2019_51698_47201.jpg

Waterside view: overview of CMP riser

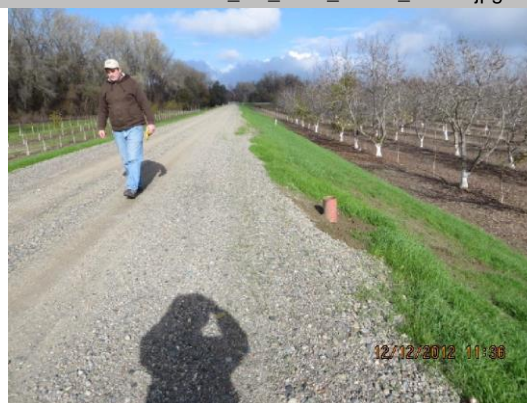
Photo 1 of 3 : UCIP_SP_2019_51724_47206.jpg

Comment Code					
Inspector Comment					
FS_ID:51724 DS_ID:17338 EP_NO: N/A Repair Type: Non-Urgent Crossing Status: Indicator Found UCIP Comments: 4/19/2017 Still only LS airvent found. (DWR Sutter Yard- Afreitag)10/31/2016 Only the LS standpipe and airvent found.6/1/2016 Still only the vaccum breaker on LS shoulder visible.4/1/2015 Only vacuum breaker found on LS shoulder.6/30/2014 Same as last inspection.12/18/2013 Same as last inspection.7/23/2013 Same as last inspection. FIELD_STRUCT_DESC: Pipe of unknown diameter, purpose and material through the levee, at an unknown depth below the crown, not found. Vacuum breaker inside steel standpipe on the landside (LS) shoulder, found in 2015. [Additional Reference(s): DWR Levee Log, 2002]. FS Date: 5/1/2017 8:31:33 AM

LM Start	8.38	Rating **	M	Issue No.	162 (cont)
LM End	8.38	Issue Type +	En	Location *

Waterside view: overview

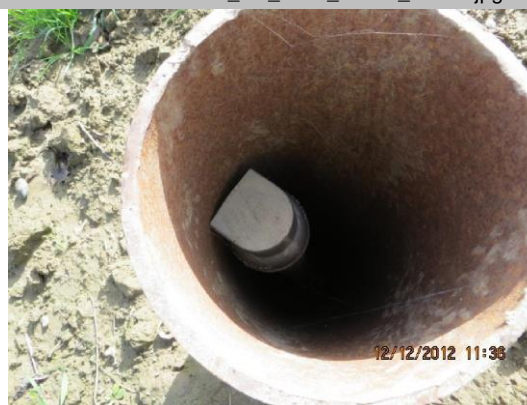
Photo 2 of 3 : UCIP_SP_2019_51724_47205.jpg

Waterside view: vacuum breaker inside a steel pipe

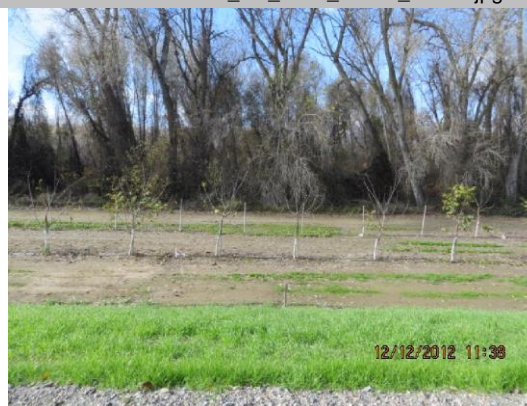
Photo 3 of 3 : UCIP_SP_2019_51724_47204.jpg

Comment Code						
Inspector Comment						
FS_ID:51724 DS_ID:17338 EP_NO: N/A Repair Type: Non-Urgent Crossing Status: Indicator Found UCIP Comments: 4/19/2017 Still only LS airvent found. (DWR Sutter Yard- Afreitag)10/31/2016 Only the LS standpipe and airvent found.6/1/2016 Still only the vaccum breaker on LS shoulder visible.4/1/2015 Only vacuum breaker found on LS shoulder.6/30/2014 Same as last inspection.12/18/2013 Same as last inspection.7/23/2013 Same as last inspection. FIELD_STRUCT_DESC: Pipe of unknown diameter, purpose and material through the levee, at an unknown depth below the crown, not found. Vacuum breaker inside steel standpipe on the landside (LS) shoulder, found in 2015. [Additional Reference(s): DWR Levee Log, 2002]. FS Date: 5/1/2017 8:31:33 AM

Landside view: overview (no pipes)

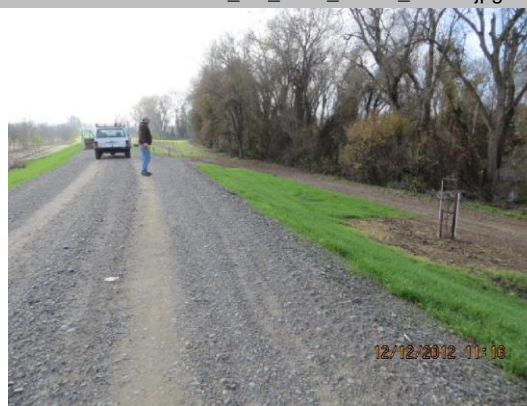
Photo 1 of 3 : UCIP_SP_2019_51726_47210.jpg

FS_ID:51726
DS_ID:17327
EP_NO: 9528
Repair Type: Non-Urgent
Crossing Status: Found
UCIP Comments: 4/19/2017 Abandoned- needs to be done so properly. (DWR Sutter Yard- Afreitag)10/31/2016 Abandoned. (DWR Sutter Yard- Afreitag)6/13/2016 Pipe was internally cleaned and camera inspected by Nor-Cal Pipeline Services on 10/29/2015. Pipe length through levee is 75.1ft long. The inspection showed some signs of rust but no holes or other deterioration were found. Pics of exposed pipe ends were uploaded on 4/1/2015. After the inspection the pipe ends were capped and reburied.4/14/2016- Same as last inspection.4/1/2015- Both ends of pipe have been dug up in preparation for internal camera inspections. Pipe shows some rust but appears to be in decent shape. Only buried slide gate structure found.6/30/2014- Same as last inspection.12/18/2013 Same as last inspection.7/23/2013 Same as last inspection.
FIELD_STRUCT_DESC: *ABANDONED* 24-inch corrugated metal drainage pipe through the levee, 12.5 feet below the crown. Slide gate on the waterside (WS). (Automatic Board Order (ABO) issued as Permit No. 9528, 1974 - Lamb). [Additional Reference(s): DWR Levee Log, 2002. USACE Sacramento O&M Manual 136, March 1960 (HLM 8.59)].

LM Start	8.56	Rating **	M	Issue No.	164 (cont)
LM End	8.56	Issue Type +	Ma	Location *

Waterside view: overview

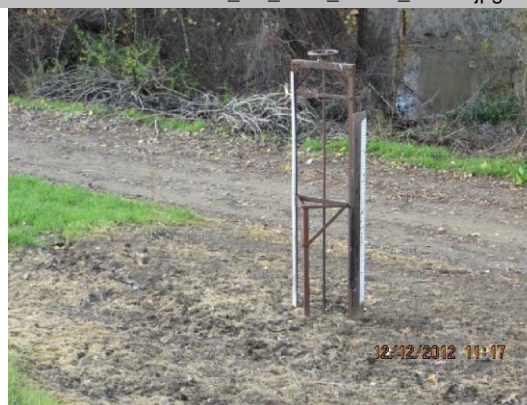
Photo 2 of 3 : UCIP_SP_2019_51726_47209.jpg

Waterside view: burried slide gate

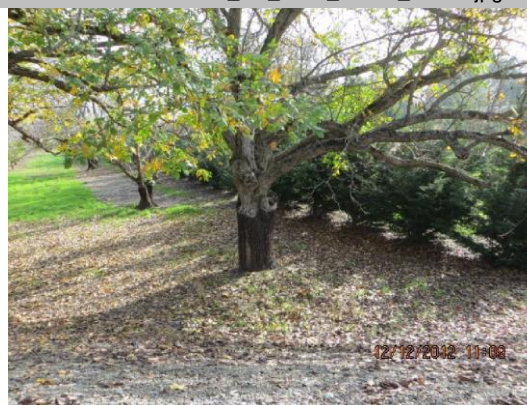
Photo 1 of 3 : UCIP_SP_2019_51728_74662.jpg

Comment Code					
Inspector Comment					
FS_ID:51728 DS_ID:17352 EP_NO: 9523 Repair Type: Non-Urgent Crossing Status: Indicator Found UCIP Comments: 4/19/2017 Abandoned- needs to be done so properly. (DWR Sutter Yard- Afreitag)10/31/2016 Abandoned. (DWR Sutter Yard- Afreitag)6/13/2016 Abandoned crossing.4/14/2016 Appears abandoned and if so, should be done so properly. Borrowing activity on landside (LS).8/28/2015 Pipe has been dug up and located along the WS levee toe.6/30/2014 Unable to locate.12/18/2013 Unable to locate.7/23/2013 Same as last inspection. Unable to locate. FIELD_STRUCT_DESC: *ABANDONED* 10-inch concrete encased steel drainage pipe through the levee, invert 15 feet below the crown, not found in 2016. Gate valve in a 42-inch corrugated metal pipe riser on the waterside (WS) slope, found in 2016. (10-inch pipe [HLM 8.7] authorized under Automatic Board Order (ABO) issued as Permit No. 9523, 1974 - Blackmore). Additional Reference(s): DWR Levee Log, 2002. USACE Sacramento O&M Manual 136, March 1960 (HLM 8.7)]. FS Date: 5/1/2017 8:59:37 AM

View of LS

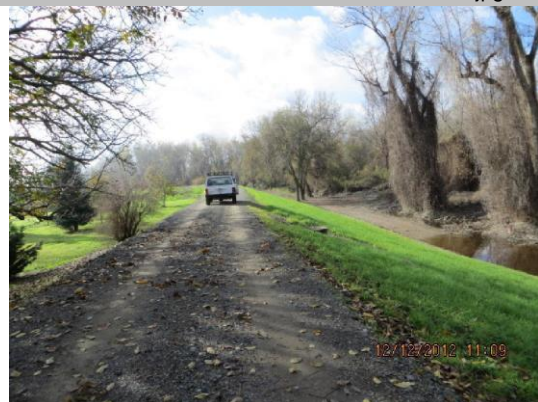
Photo 3 of 3 : UCIP_SP_2019_51728_74660.jpg

Comment Code						
Inspector Comment						
FS_ID:51728 DS_ID:17352 EP_NO: 9523 Repair Type: Non-Urgent Crossing Status: Indicator Found UCIP Comments: 4/19/2017 Abandoned- needs to be done so properly. (DWR Sutter Yard- Afreitag)10/31/2016 Abandoned. (DWR Sutter Yard- Afreitag)6/13/2016 Abandoned crossing.4/14/2016 Appears abandoned and if so, should be done so properly. Borrowing activity on landside (LS).8/28/2015 Pipe has been dug up and located along the WS levee toe.6/30/2014 Unable to locate.12/18/2013 Unable to locate.7/23/2013 Same as last inspection. Unable to locate. FIELD_STRUCT_DESC: *ABANDONED* 10-inch concrete encased steel drainage pipe through the levee, invert 15 feet below the crown, not found in 2016. Gate valve in a 42-inch corrugated metal pipe riser on the waterside (WS) slope, found in 2016. (10-inch pipe [HLM 8.7] authorized under Automatic Board Order (ABO) issued as Permit No. 9523, 1974 - Blackmore).Additional Reference(s): DWR Levee Log, 2002. USACE Sacramento O&M Manual 136, March 1960 (HLM 8.7)]. FS Date: 5/1/2017 8:59:37 AM

View from crown of levee looking downstream.

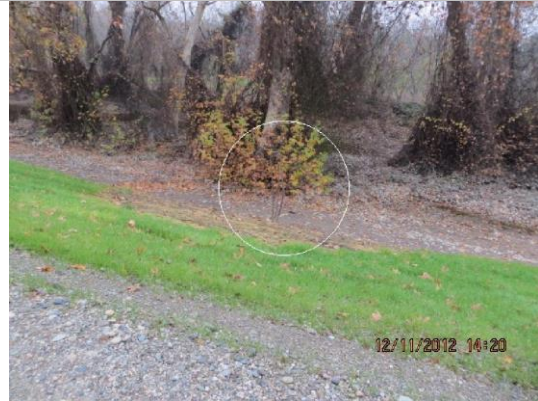
Photo 1 of 3 : UCIP_SP_2019_53402_47216.jpg

FS_ID:53402
DS_ID:17353
EP_NO: 4491
Repair Type: Urgent
Crossing Status: Found
UCIP Comments: 8/30/2018 Same as last inspection; could not find LS pipe end so recommend internal pipe inspection. Crossing to remain Urgent (D. Sanoski - DWR UCIP).4/19/2017 4in. pipe still showing signs of deterioration near WS toe. (DWR Sutter Yard- Afreitag)10/31/2016 Pipe still exposed along the WS toe and is rusted and corroded. If it is still in use by the owner then it should be rebuilt.(DWR Sutter Yard- Afreitag)6/13/2016 Pipe was dug up on WS and photographed. It was originally selected for internal inspection but was unable to be as there was no access to the inside of the 4" pipe. (DWR Sutter Yard - afreitag)4/14/2016 Signs of corrosion on pipe and valve on LS. Pipe in use according to Bryan Reniff of Sutter Yard. (DWR UCIP - kfazel)8/28/2015 Pipe was dug up and located on the WS levee toe. (DWR Sutter Yard - afreitag)6/30/2014 Same as last inspection. (DWR Sutter Yard - afreitag)12/18/2013 Same as last inspection. (DWR Sutter Yard - afreitag)7/23/2013 Same as last inspection. (DWR Sutter Yard - afreitag)12/11/2012 Only abandoned slide gate found on WS. (DWR UCIP - pamatya)

FIELD_STRUCT_DESC: 4-inch steel drainage pipe sleeved through 24-inch corrugated metal pipe through the levee, 16.7 feet below the crown. Annular space has been pressure grouted. Slide gate on the waterside (WS) end. Gate valve at the landside (LS) toe. (Permit No. 4491, 1964 - Blackmore). [Additional Reference(s): DWR Levee Log, 2002. USACE Sacramento O&M Manual 136, March 1960 (HLM 8.74)].
FS Date: 8/30/2018 4:27:57 PM

Waterside view: overview of slide gate on steel structure (belongs to crossing at CLM-8.782)

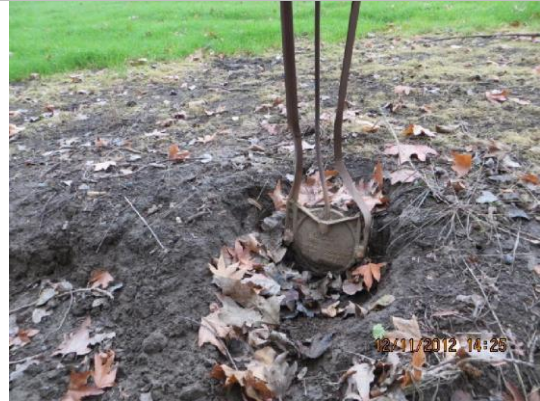
Photo 2 of 3 : UCIP_SP_2019_53402_47215.jpg

FS_ID:53402
DS_ID:17353
EP_NO: 4491
Repair Type: Urgent
Crossing Status: Found
UCIP Comments: 8/30/2018 Same as last inspection; could not find LS pipe end so recommend internal pipe inspection. Crossing to remain Urgent (D. Sanoski - DWR UCIP).4/19/2017 4in. pipe still showing signs of deterioration near WS toe. (DWR Sutter Yard- Afreitag)10/31/2016 Pipe still exposed along the WS toe and is rusted and corroded. If it is still in use by the owner then it should be rebuilt.(DWR Sutter Yard- Afreitag)6/13/2016 Pipe was dug up on WS and photographed. It was originally selected for internal inspection but was unable to be as there was no access to the inside of the 4" pipe. (DWR Sutter Yard - afreitag)4/14/2016 Signs of corrosion on pipe and valve on LS. Pipe in use according to Bryan Reniff of Sutter Yard. (DWR UCIP - kfazel)8/28/2015 Pipe was dug up and located on the WS levee toe. (DWR Sutter Yard - afreitag)6/30/2014 Same as last inspection. (DWR Sutter Yard - afreitag)12/18/2013 Same as last inspection. (DWR Sutter Yard - afreitag)7/23/2013 Same as last inspection. (DWR Sutter Yard - afreitag)12/11/2012 Only abandoned slide gate found on WS. (DWR UCIP - pamatya)

Waterside view: slide gate on steel structure (belongs to crossing at CLM-8.782)

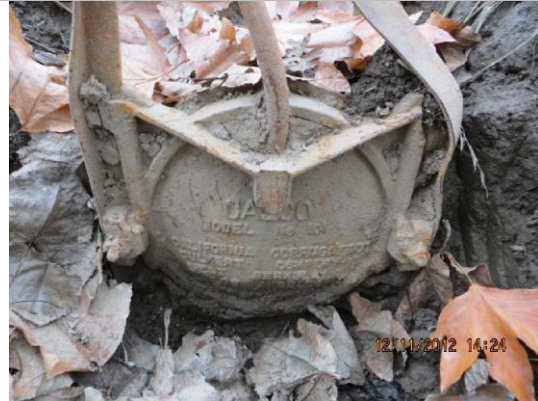
Photo 3 of 3 : UCIP_SP_2019_53402_47214.jpg

FS_ID:53402
DS_ID:17353
EP_NO: 4491
Repair Type: Urgent
Crossing Status: Found
UCIP Comments: 8/30/2018 Same as last inspection; could not find LS pipe end so recommend internal pipe inspection. Crossing to remain Urgent (D. Sanoski - DWR UCIP).4/19/2017 4in. pipe still showing signs of deterioration near WS toe. (DWR Sutter Yard-Afreitag)10/31/2016 Pipe still exposed along the WS toe and is rusted and corroded. If it is still in use by the owner then it should be rebuilt.(DWR Sutter Yard- Afreitag)6/13/2016 Pipe was dug up on WS and photographed. It was originally selected for internal inspection but was unable to be as there was no access to the inside of the 4" pipe. (DWR Sutter Yard - afreitag)4/14/2016 Signs of corrosion on pipe and valve on LS. Pipe in use according to Bryan Reniff of Sutter Yard. (DWR UCIP - kfazel)8/28/2015 Pipe was dug up and located on the WS levee toe. (DWR Sutter Yard - afreitag)6/30/2014 Same as last inspection. (DWR Sutter Yard - afreitag)12/18/2013 Same as last inspection. (DWR Sutter Yard - afreitag)7/23/2013 Same as last inspection. (DWR Sutter Yard - afreitag)12/11/2012 Only abandoned slide gate found on WS. (DWR UCIP - pamatya)

Waterside view: close view of slide gate (belongs to crossing at CLM-8.782)

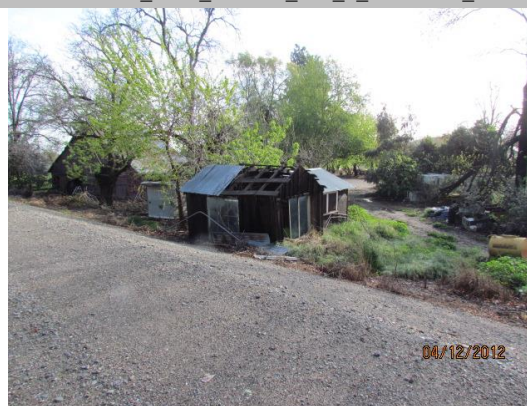
Photo 1 of 1 : SP_2019_ST0003_264_2_20190327_00002.jpg

LM Start	8.75	Rating **	U	Issue No.	2
LM End	8.75	Issue Type +	En	Location *	LS
Category	Earthen Levee			GPS Latitude/Longitude	
				Start	End
Item	Encroachments			39.252260 °	39.252260 °
				-121.997721 °	-121.997721 °
DWR ID	DWR_ST0003_01_s_2012_2				
Comment Code					
BU : Building					
Inspector Comment

View of the building next to the toe of the levee.

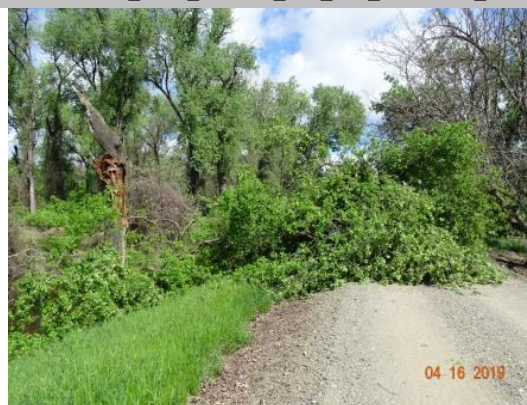
Photo 1 of 1 : SP_2019_ST0003_264_119_20190418_00191.jpg

LM Start	8.77	Rating **	U	Issue No.	119
LM End	8.77	Issue Type +	Ma	Location *	CR
Category	Earthen Levee			GPS Latitude/Longitude	
				Start	End
Item	Encroachments			39.252515 °	39.252515 °
				-121.997678 °	-121.997678 °
DWR ID	DWR_ST0003_01_s_2019_119				
Comment Code					
TR : Tree or limb					
Inspector Comment

View of a large fallen tree blocking access. Spring 2019.

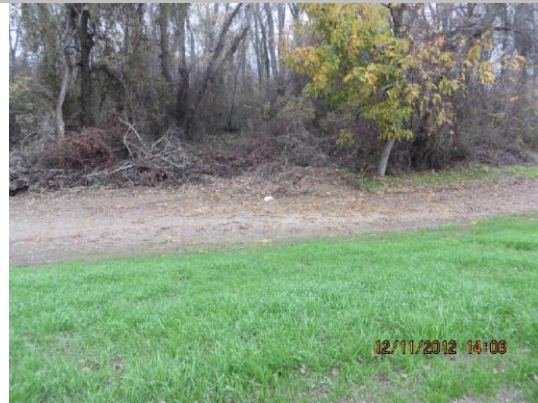
Photo 1 of 3 : UCIP_SP_2019_51731_47242.jpg

FS_ID:51731
DS_ID:17355
EP_NO: N/A
Repair Type: No Action Needed
Crossing Status: Found
UCIP Comments: 4/19/2017 Abandoned- needs to be done so properly. (DWR Sutter Yard- Afreitag)10/31/2016 Abandoned. (DWR Sutter Yard- Afreitag)6/13/2016 Pipe was internally cleaned and camera inspected on 10/30/2015 by Nor-Cal Pipeline Services. WS cap was removed and 100.6ft of pipe were inspected starting from the WS opening. Inspection revealed rusting but no visible holes or other deterioration were found. Pipe was recapped after the inspection. This pipe is always visible so no new photos were taken during the inspection.6/9/2016 Khalida Fazel of UCIP requests that any photos of the pipe when it was exposed for a video inspection be kindly uploaded here.4/1/2015 Pipe is in same condition. It has been selected for an internal camera inspection. New CMP pipe on WS capped with steel plate.6/30/2014 Same as last inspection.12/18/2013 Same as last inspection.7/23/2013 Same as last inspection.

LM Start	9.37	Rating **	A/W	Issue No.	167 (cont)
LM End	9.37	Issue Type +	Ma	Location *

Waterside view: overview

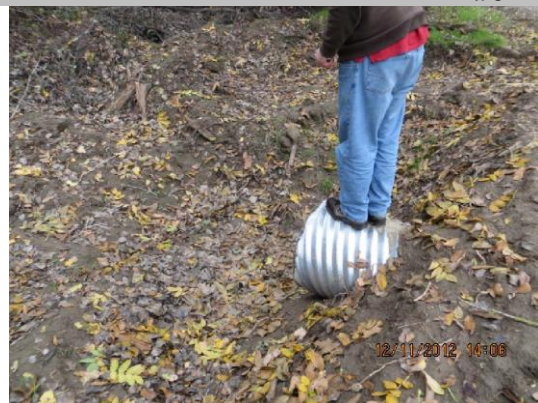
Photo 2 of 3 : UCIP_SP_2019_51731_47241.jpg

Waterside view: overview of CMP pipe

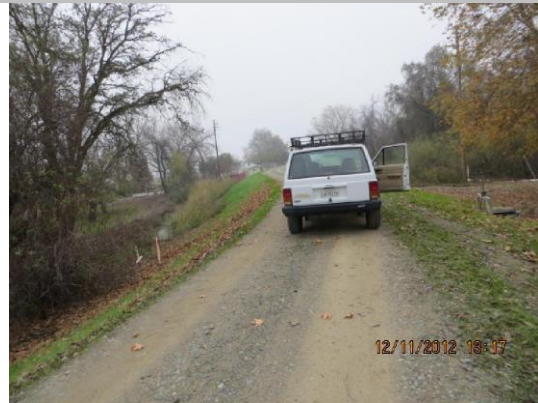
Photo 1 of 3 : UCIP_SP_2019_51734_47263.jpg

Comment Code					
Inspector Comment					
FS_ID:51734 DS_ID:17358 EP_NO: 9517 Repair Type: No Action Needed Crossing Status: Found UCIP Comments: 4/19/2017 No WS end found/ slide gate handle broken. (DWR Sutter Yard- Afreitag)10/31/2016 Slide gate handle is broken and no WS pipe end can be located. (DWR Sutter Yard- Afreitag)6/1/2016 WS slide gate handle is still broken. No WS pipe end was found.4/1/2015 Slide gate handle is still broken. The rest of the pipe appears in good condition. Broken slide gate handle found on WS.6/30/2014 Same as last inspection.12/18/2013 Same as last inspection.7/23/2013 Same as last inspection. FIELD_STRUCT_DESC: 48-inch corrugated metal drainage pipe through the levee, 14 feet below the crown. Slide gate in a 60-inch corrugated metal pipe (CMP) riser on the waterside (WS) slope. Slide gate in a concrete distribution box on the landside (LS) toe. (48-inch pipe [HLM 10.39] authorized under Automatic Board Order (ABO) issued as Permit No. 9517, 1974 - Griffin). [Additional Reference(s): DWR Levee Log, 2002. USACE Sacramento O&M Manual 136, March 1960 (HLM 10.47)]. FS Date: 5/1/2017 9:32:45 AM

Crown view: overview (both sides of the levee)

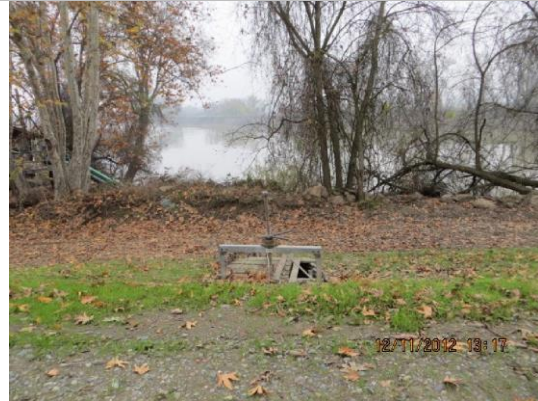
Photo 2 of 3 : UCIP_SP_2019_51734_47262.jpg

Item	DWR UCIP LMA Responsibility			39.270492 °	39.270492 °	
				-122.001306 °	-122.001306 °	
DWR ID	17358					
Comment Code						
Inspector Comment						
FS_ID:51734 DS_ID:17358 EP_NO: 9517 Repair Type: No Action Needed Crossing Status: Found UCIP Comments: 4/19/2017 No WS end found/ slide gate handle broken. (DWR Sutter Yard- Afreitag)10/31/2016 Slide gate handle is broken and no WS pipe end can be located. (DWR Sutter Yard- Afreitag)6/1/2016 WS slide gate handle is still broken. No WS pipe end was found.4/1/2015 Slide gate handle is still broken. The rest of the pipe appears in good condition. Broken slide gate handle found on WS.6/30/2014 Same as last inspection.12/18/2013 Same as last inspection.7/23/2013 Same as last inspection. FIELD_STRUCT_DESC: 48-inch corrugated metal drainage pipe through the levee, 14 feet below the crown. Slide gate in a 60-inch corrugated metal pipe (CMP) riser on the waterside (WS) slope. Slide gate in a concrete distribution box on the landside (LS) toe. (48-inch pipe [HLM 10.39] authorized under Automatic Board Order (ABO) issued as Permit No. 9517, 1974 - Griffin). [Additional Reference(s): DWR Levee Log, 2002. USACE Sacramento O&M Manual 136, March 1960 (HLM 10.47)]. FS Date: 5/1/2017 9:32:45 AM

LM Start	10.35	Rating **	A/W	Issue No.	168 (cont)
LM End	10.35	Issue Type +	Ma	Location *

Waterside view: overview of CMP riser

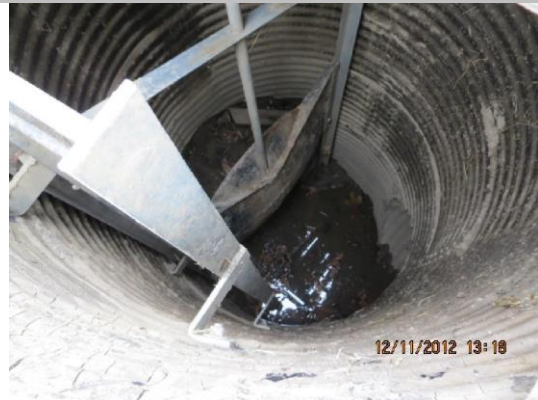
Photo 3 of 3 : UCIP_SP_2019_51734_47268.jpg

Waterside view: inside CMP riser

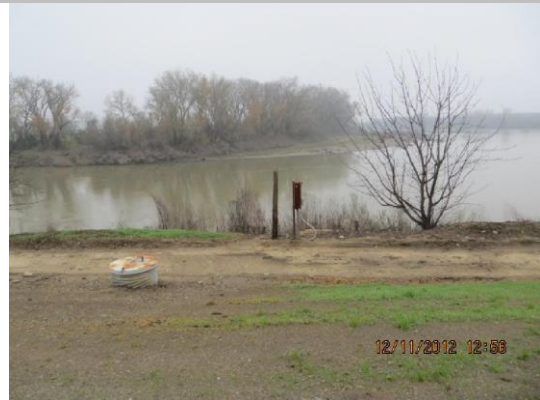
Photo 1 of 3 : UCIP_SP_2019_51735_47270.jpg

Comment Code					
Inspector Comment					
FS_ID:51735 DS_ID:17371 EP_NO: 9517 Repair Type: Non-Urgent Crossing Status: Found UCIP Comments: 4/19/2017 Abandoned- needs to be done so properly. (DWR Sutter Yard- Afreitag)10/31/2016 Abandoned. (DWR Sutter Yard- Afreitag)6/1/2016 Abandoned crossing.4/2/2015 Same as last inspection. Need to verify type of abandonment. Pump house not found on waterside of the levee. Looks abandoned as switch panel found without pump.6/30/2014 Same as last inspection.12/18/2013 Same as last inspection.7/23/2013 Same as last inspection. FIELD_STRUCT_DESC: *ABANDONED* 18-inch steel irrigation pipe through the levee, 17.1 feet below the crown. Gate valve and flap gate in a concrete distribution box. Water meter in a corrugated metal pipe (CMP) riser at the landside (LS) toe. Gate valve in a CMP on the waterside (WS). Pipe was replaced in November 2005. (Automatic Board Order (ABO) issued as Permit No. 9517, 1974 - Griffin). [Additional Reference(s): DWR Levee Log, 2002. USACE Sacramento O&M Manual 136, March 1960 (HLM 10.53)]. FS Date: 5/1/2017 9:39:39 AM

Waterside view: CMP riser and abandoned service pole

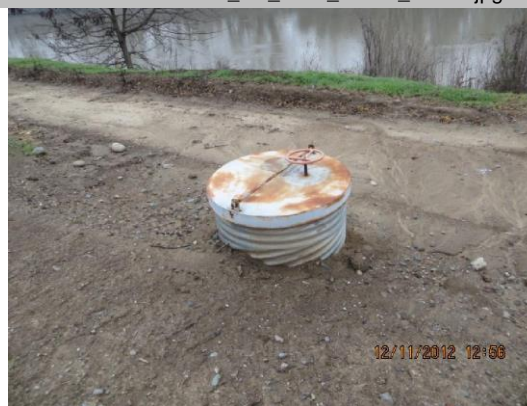
Photo 2 of 3 : UCIP_SP_2019_51735_47269.jpg

Item	DWR UCIP Field Study			39.271928 °	39.271928 °	
				-122.003422 °	-122.003422 °	
DWR ID	17371					
Comment Code						
Inspector Comment						
FS_ID:51735 DS_ID:17371 EP_NO: 9517 Repair Type: Non-Urgent Crossing Status: Found UCIP Comments: 4/19/2017 Abandoned- needs to be done so properly. (DWR Sutter Yard- Afreitag)10/31/2016 Abandoned. (DWR Sutter Yard- Afreitag)6/1/2016 Abandoned crossing.4/2/2015 Same as last inspection. Need to verify type of abandonment. Pump house not found on waterside of the levee. Looks abandoned as switch panel found without pump.6/30/2014 Same as last inspection.12/18/2013 Same as last inspection.7/23/2013 Same as last inspection. FIELD_STRUCT_DESC: *ABANDONED* 18-inch steel irrigation pipe through the levee, 17.1 feet below the crown. Gate valve and flap gate in a concrete distribution box. Water meter in a corrugated metal pipe (CMP) riser at the landside (LS) toe. Gate valve in a CMP on the waterside (WS). Pipe was replaced in November 2005. (Automatic Board Order (ABO) issued as Permit No. 9517, 1974 - Griffin). [Additional Reference(s): DWR Levee Log, 2002. USACE Sacramento O&M Manual 136, March 1960 (HLM 10.53)]. FS Date: 5/1/2017 9:39:39 AM

Waterside view: CMP riser with gate valve

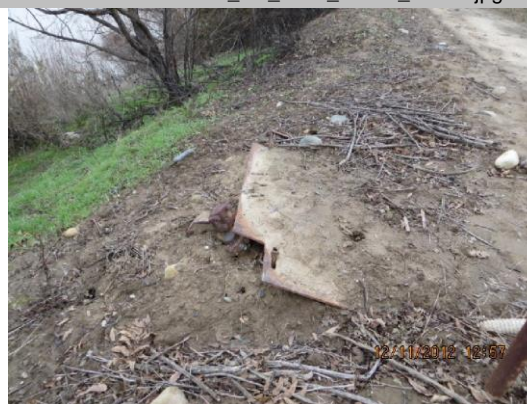
Photo 3 of 3 : UCIP_SP_2019_51735_47273.jpg

Waterside view: abandoned pump station.

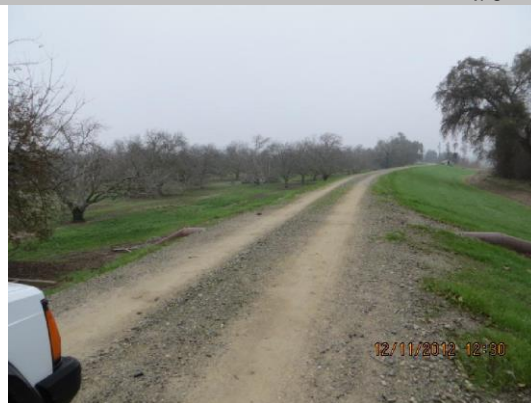
Photo 1 of 3 : UCIP_SP_2019_51737_47284.jpg

FS_ID:51737
DS_ID:17350
EP_NO: 1369
Repair Type: Non-Urgent
Crossing Status: Found
UCIP Comments: 4/19/2017 Abandoned- needs to be done so properly. (DWR Sutter Yard- A Freitag)10/31/2016 Appears abandoned. (DWR Sutter Yard- A Freitag)6/1/2016 Appears to be an abandoned crossing.4/2/2015 Same as last inspection. Looks abandoned and if so should be done so properly. Pump and switch panel not found. Outlet pipe blocked by silt and debris.6/30/2014 Same as last inspection.12/18/2013 Same as last inspection.7/23/2013 Same as last inspection.
FIELD_STRUCT_DESC: *ABANDONED* 24-inch steel irrigation pipe through the levee, 4 feet below the crown. Siphon breaker on the landside (LS) slope. Concrete distribution box on the LS toe. (Permit No. 1369, 1949 - Griffin). [Additional Reference(s): DWR Levee Log, 2002. USACE Sacramento O&M Manual 136, March 1960 (HLM 10.68)].
FS Date: 5/1/2017 9:44:43 AM

Crown view: overview (both sides of the levee)

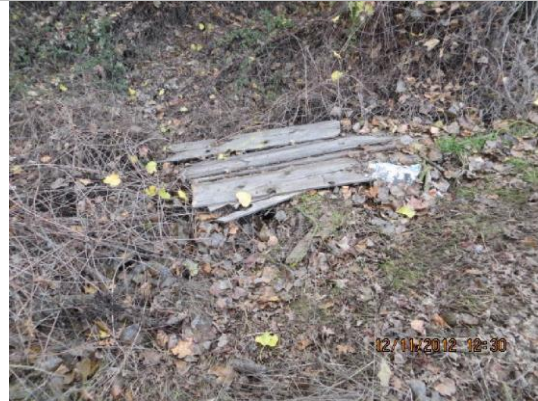
Photo 3 of 3 : UCIP_SP_2019_51737_47287.jpg

Comment Code					
Inspector Comment					
FS_ID:51737 DS_ID:17350 EP_NO: 1369 Repair Type: Non-Urgent Crossing Status: Found UCIP Comments: 4/19/2017 Abandoned- needs to be done so properly. (DWR Sutter Yard- Afreitag)10/31/2016 Appears abandoned. (DWR Sutter Yard- Afreitag)6/1/2016 Appears to be an abandoned crossing.4/2/2015 Same as last inspection. Looks abandoned and if so should be done so properly. Pump and switch panel not found. Outlet pipe blocked by silt and debris.6/30/2014 Same as last inspection.12/18/2013 Same as last inspection.7/23/2013 Same as last inspection. FIELD_STRUCT_DESC: *ABANDONED* 24-inch steel irrigation pipe through the levee, 4 feet below the crown. Siphon breaker on the landside (LS) slope. Concrete distribution box on the LS toe. (Permit No. 1369, 1949 - Griffin). [Additional Reference(s): DWR Levee Log, 2002. USACE Sacramento O&M Manual 136, March 1960 (HLM 10.68)]. FS Date: 5/1/2017 9:44:43 AM

Waterside view: beyond exposed steel pipe (not accessible)

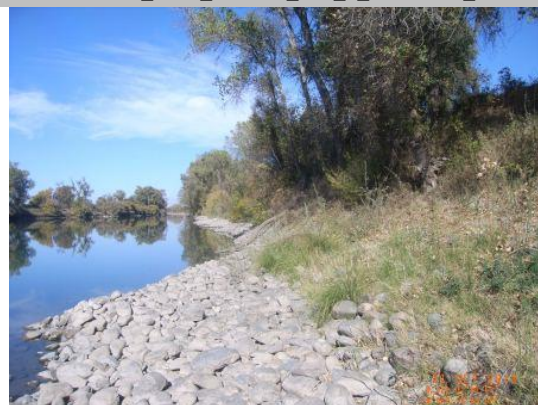
Photo 1 of 1 : SP_2019_ST0003_264_8_20190327_00006.jpg

LM Start	11.53	Rating **	A/W	Issue No.	8
LM End	11.79	Issue Type +	Ma	Location *	WS
Category	Supplemental			GPS Latitude/Longitude	
				Start	End
Item	2017 USACE Erosion Survey, DRAFT			39.279910 °	39.283853 °
				-122.018221 °	-122.016113 °
DWR ID	DWR_ST0003_01_f_2018_8				
Comment Code					
Inspector Comment					
2017 Site ID: SAC 152.6 L					
Status: Eroding					
2017 Field Notes: Access Issues - Could not observe					
Site History: 2008 - Large rotational/mass failure in the bank with tree slump. 2009 - Minimal new erosion, the tree is leaning further into the river. 2011 - Site extended downstream. 2012 - Minor new erosion and tree roots are further exposed.

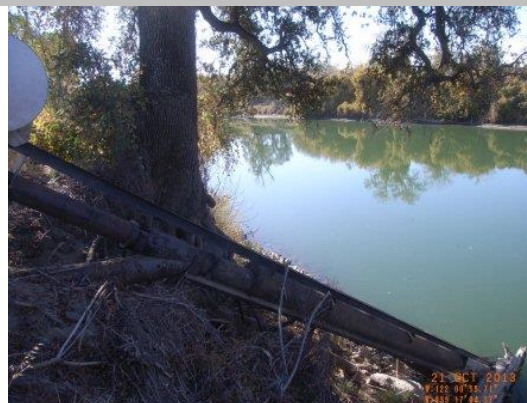
Photo 1 of 1 : SP_2019_ST0003_264_13_20190327_00009.jpg

LM Start	11.85	Rating **	A/W	Issue No.	13
LM End	11.90	Issue Type +	Ma	Location *	WS
Category	Supplemental			GPS Latitude/Longitude	
				Start	End
Item	2017 USACE Erosion Survey, DRAFT			39.284568 °	39.285298 °
				-122.015690 °	-122.015208 °
DWR ID	DWR_ST0003_01_f_2018_13				
Comment Code					
Inspector Comment					
2017 Site ID: SAC 152.8 L					
Status: Eroding					
2017 Field Notes: Minor new erosion observed.					
Site History: 2006 - Large rotational/mass failure in the bank with tree slump. Tough clayey toe material. 2007 - Site is between stone revetments with a pump station at the downstream end. 2010 - Erosion is into the levee toe. 2011 - Minor new erosion. 2012 - Minor new erosion.

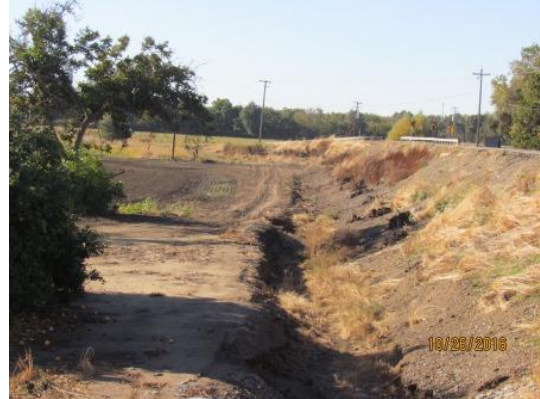
Photo 1 of 1 : SP_2019_ST0003_264_7_20190327_00005.jpg

LM Start	11.94	Rating **	M	Issue No.	7
LM End	12.18	Issue Type +	En	Location *	LS
Category	Earthen Levee			GPS Latitude/Longitude	
				Start	End
Item	Encroachments			39.285658 °	39.288978 °
				-122.014574 °	-122.013892 °
DWR ID	DWR_ST0003_01_s_2012_7				
Comment Code					
DT : Ditch					
Inspector Comment

View of the ditch along the landside toe.

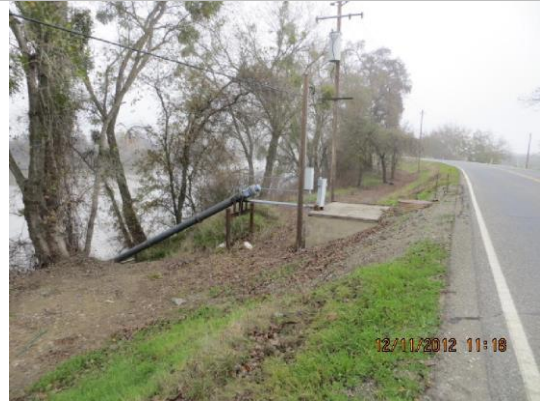
Photo 1 of 3 : UCIP_SP_2019_51743_47306.jpg

Comment Code						
Inspector Comment						
FS_ID:51743 DS_ID:17365 EP_NO: 9514 Repair Type: Non-Urgent Crossing Status: Found UCIP Comments: 4/19/2017 Crossing appears to be in good condition. (DWR Sutter Yard- Afreitag)10/31/2016 Crossing appears to be in good condition.(DWR Sutter Yard- Afreitag)6/6/2016 Crossing appears to be in good condition. New wooden cover was made for WS surge tank.4/2/2015 Everything looked to be in good condition. Concrete surge tank still has some silting. Gate valve in CMP riser not visible. Flap gate in concrete distribution box on LS not visible/accessible. Looks like cleaning required inside concrete surge tank on WS due to silting.7/2/2014 Same as last inspection.12/30/2013 Same as last inspection.7/29/2013 Pump running and WS surge tank was full of water so not sure if silt was cleaned out. LS flap gate was visible and is in good condition. FIELD_STRUCT_DESC: 36-inch corrugated metal irrigation pipe through the levee, 18.1 feet below the crown. Pump house on the waterside (WS) slope. Gate valve in a corrugated metal riser on the WS toe. Flap gate in a concrete distribution box at the landside (LS) toe. (Automatic Board Order (ABO) issued as Permit No. 9514, 1974 - Boggs). [Additional Reference(s): Levee Log, 2002. USACE Sacramento O&M Manual 136, March 1960 (HLM 12.05)]. FS Date: 5/1/2017 9:57:28 AM

Waterside view: overview pipe, pump, surge box & CMP riser

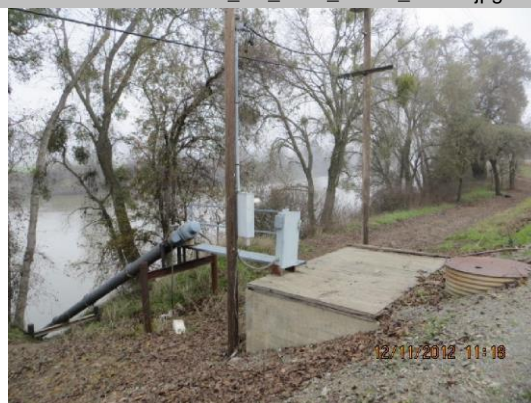
Photo 2 of 3 : UCIP_SP_2019_51743_47305.jpg

Item	DWR UCIP Field Study			39.287251 °	39.287251 °	
				-122.014076 °	-122.014076 °	
DWR ID	17365					
Comment Code						
Inspector Comment						
FS_ID:51743 DS_ID:17365 EP_NO: 9514 Repair Type: Non-Urgent Crossing Status: Found UCIP Comments: 4/19/2017 Crossing appears to be in good condition. (DWR Sutter Yard- A Freitag)10/31/2016 Crossing appears to be in good condition.(DWR Sutter Yard- A Freitag)6/6/2016 Crossing appears to be in good condition. New wooden cover was made for WS surge tank.4/2/2015 Everything looked to be in good condition. Concrete surge tank still has some silting. Gate valve in CMP riser not visible. Flap gate in concrete distribution box on LS not visible/accessible. Looks like cleaning required inside concrete surge tank on WS due to silting.7/2/2014 Same as last inspection.12/30/2013 Same as last inspection.7/29/2013 Pump running and WS surge tank was full of water so not sure if silt was cleaned out. LS flap gate was visible and is in good condition. FIELD_STRUCT_DESC: 36-inch corrugated metal irrigation pipe through the levee, 18.1 feet below the crown. Pump house on the waterside (WS) slope. Gate valve in a corrugated metal riser on the WS toe. Flap gate in a concrete distribution box at the landside (LS) toe. (Automatic Board Order (ABO) issued as Permit No. 9514, 1974 - Boggs). [Additional Reference(s): Levee Log, 2002. USACE Sacramento O&M Manual 136, March 1960 (HLM 12.05)]. FS Date: 5/1/2017 9:57:28 AM

Waterside view: steel pipe, pump, surge box & CMP riser

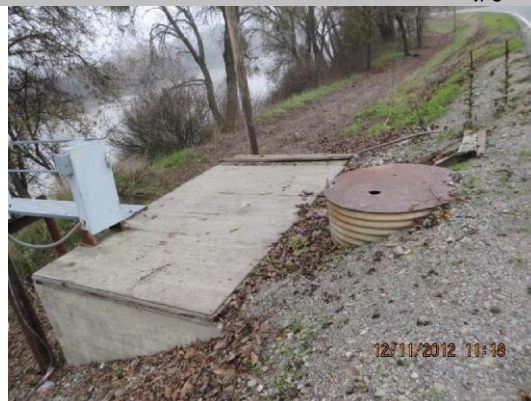
Photo 3 of 3 : UCIP_SP_2019_51743_47304.jpg

Waterside view: pump switch box, surge box & CMP riser

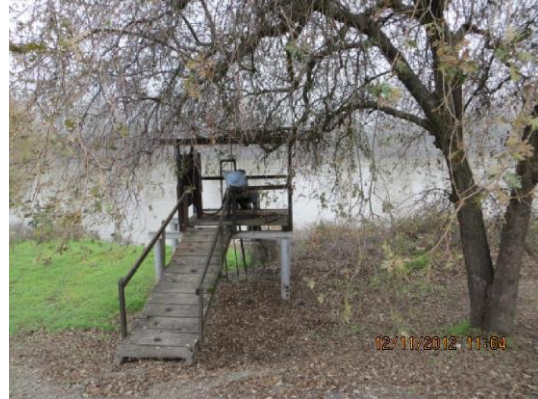
Photo 1 of 3 : UCIP_SP_2019_51744_47313.jpg

FS_ID:51744
DS_ID:17366
EP_NO: 9513
Repair Type: Non-Urgent
Crossing Status: Found
UCIP Comments: 4/20/2017 2.5in. GI pipe was removed and replaced with a section of 2.5in. flexible hose that can easily be removed to allow the slide gate to fully close for high water season. (DWR Sutter Yard- Afreitag)10/31/2016 2.5in. pipe still blocking the screwgate. (DWR Sutter Yard- Afreitag)6/6/2016 2.5inch pipe still present through crossing. (DWR Sutter Yard - afreitag)4/14/2016 2.5-inch pipe still preventing slide gate from fully closing on WS. Recommend LMA contact owner to address removal of unauthorized 2.5-inch pipe. Owner must either contact CVFPB for permitting of 2.5-inch pipe or remove it. (DWR UCIP - kfazel)4/2/2015 2.5in pipe is still present and prevents the slide gate from fully closing. (DWR Sutter Yard - afreitag)7/2/2014 2.5in. GI pipe and chain in WS surge box will prevent slide gate from closing fully for high water season. (DWR Sutter Yard - afreitag)12/30/2013 Same as last inspection. (DWR Sutter Yard - afreitag)7/29/2013 2.5in. GI pipe and chain in WS surge box will prevent slide gate from closing fully for high water season. (DWR Sutter Yard - afreitag)12/11/2012 A 2.5 inch GI pipe through 36 inch CMP found. A 2 inch electrical conduit also found. (DWR UCIP - pamatya)

FIELD_STRUCT_DESC: 24-inch corrugated metal irrigation pipe through the levee, invert 16.5 feet below the crown. Slide gate in a concrete surge box on the waterside (WS) berm. 2.5-inch pipe through the 24-inch pipe preventing closing of the slide gate on the WS. Slant pump on the riverbank. Concrete distribution box at the landside (LS) toe. 2-inch electrical conduit through the levee, visible on the WS adjacent to the walkway. (Automatic Board Order (ABO) issued as Permit No. 9513, 1974 - Boggs). [Additional Reference(s): DWR Levee Log, 2002. USACE Sacramento O&M Manual 136, March 1960 (HLM 12.42)].
FS Date: 5/1/2017 9:58:54 AM

Waterside view: overview of slanted pump and shed

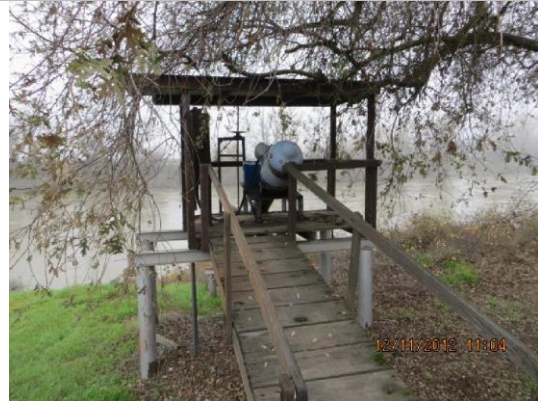
Photo 2 of 3 : UCIP_SP_2019_51744_47312.jpg

FS_ID:51744
DS_ID:17366
EP_NO: 9513
Repair Type: Non-Urgent
Crossing Status: Found
UCIP Comments: 4/20/2017 2.5in. GI pipe was removed and replaced with a section of 2.5in. flexible hose that can easily be removed to allow the slide gate to fully close for high water season. (DWR Sutter Yard- Afreitag)10/31/2016 2.5in. pipe still blocking the screwgate. (DWR Sutter Yard- Afreitag)6/6/2016 2.5inch pipe still present through crossing. (DWR Sutter Yard - afreitag)4/14/2016 2.5-inch pipe still preventing slide gate from fully closing on WS. Recommend LMA contact owner to address removal of unauthorized 2.5-inch pipe. Owner must either contact CVFPB for permitting of 2.5-inch pipe or remove it. (DWR UCIP - kfazel)4/2/2015 2.5in pipe is still present and prevents the slide gate from fully closing. (DWR Sutter Yard - afreitag)7/2/2014 2.5in. GI pipe and chain in WS surge box will prevent slide gate from closing fully for high water season. (DWR Sutter Yard - afreitag)12/30/2013 Same as last inspection. (DWR Sutter Yard - afreitag)7/29/2013 2.5in. GI pipe and chain in WS surge box will prevent slide gate from closing fully for high water season. (DWR Sutter Yard - afreitag)12/11/2012 A 2.5 inch GI pipe through 36 inch CMP found. A 2 inch electrical conduit also found. (DWR UCIP - pamatya)

Waterside view: pump station and walkway

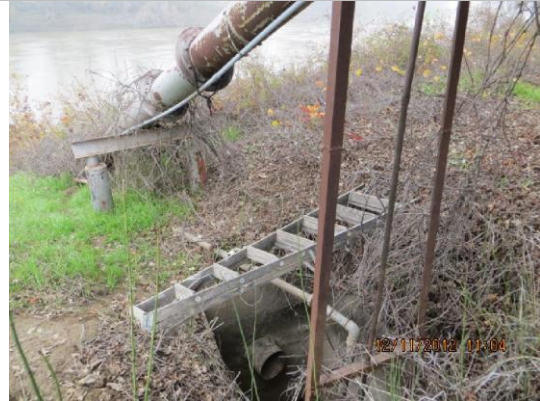
Photo 3 of 3 : UCIP_SP_2019_51744_47311.jpg

FS_ID:51744
DS_ID:17366
EP_NO: 9513
Repair Type: Non-Urgent
Crossing Status: Found
UCIP Comments: 4/20/2017 2.5in. GI pipe was removed and replaced with a section of 2.5in. flexible hose that can easily be removed to allow the slide gate to fully close for high water season. (DWR Sutter Yard- Afreitag)10/31/2016 2.5in. pipe still blocking the screwgate. (DWR Sutter Yard- Afreitag)6/6/2016 2.5inch pipe still present through crossing. (DWR Sutter Yard - afreitag)4/14/2016 2.5-inch pipe still preventing slide gate from fully closing on WS. Recommend LMA contact owner to address removal of unauthorized 2.5-inch pipe. Owner must either contact CVFPB for permitting of 2.5-inch pipe or remove it. (DWR UCIP - kfazel)4/2/2015 2.5in pipe is still present and prevents the slide gate from fully closing. (DWR Sutter Yard - afreitag)7/2/2014 2.5in. GI pipe and chain in WS surge box will prevent slide gate from closing fully for high water season. (DWR Sutter Yard - afreitag)12/30/2013 Same as last inspection. (DWR Sutter Yard - afreitag)7/29/2013 2.5in. GI pipe and chain in WS surge box will prevent slide gate from closing fully for high water season. (DWR Sutter Yard - afreitag)12/11/2012 A 2.5 inch GI pipe through 36 inch CMP found. A 2 inch electrical conduit also found. (DWR UCIP - pamatya)

FIELD_STRUCT_DESC: 24-inch corrugated metal irrigation pipe through the levee, invert 16.5 feet below the crown. Slide gate in a concrete surge box on the waterside (WS) berm. 2.5-inch pipe through the 24-inch pipe preventing closing of the slide gate on the WS. Slant pump on the riverbank. Concrete distribution box at the landside (LS) toe. 2-inch electrical conduit through the levee, visible on the WS adjacent to the walkway. (Automatic Board Order (ABO) issued as Permit No. 9513, 1974 - Boggs). [Additional Reference(s): DWR Levee Log, 2002. USACE Sacramento O&M Manual 136, March 1960 (HLM 12.42)].
FS Date: 5/1/2017 9:58:54 AM

Waterside view: steel pipe, GI pipe in concrete surge box

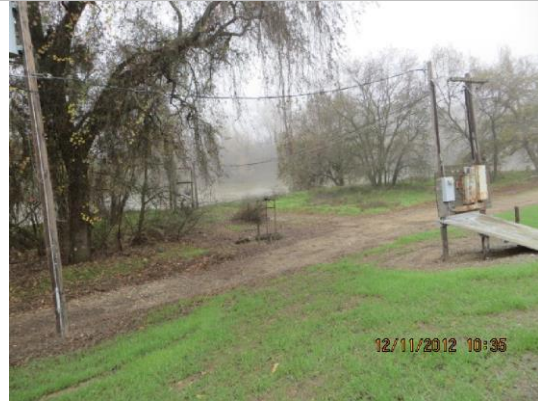
Photo 1 of 3 : UCIP_SP_2019_53403_47323.jpg

FS_ID:53403
DS_ID:17367
EP_NO: 2971
Repair Type: Urgent
Crossing Status: Found
UCIP Comments: 8/30/2018 Same as last inspection; large sink hole/erosion around surge box on WS so crossing remains Urgent (D. Sanoski - DWR UCIP). 4/20/2017 Sink hole behind the WS surge box got a lot bigger after the high water event of Jan/Feb 2017. Pipe also had a leak during that time but not sure if it was due to the sink hole or a faulty slide gate. (DWR Sutter Yard- AFreitag)10/31/2016 No repairs have been made here yet. Sinkhole is still present at the WS surge box. (DWR Sutter Yard- AFreitag)6/6/2016 Pumps were connected to intake pipes and pumping into the WS surge box. The deep sink hole above the surge box measures to be about 6'6" deep from the toe road surface and it appeared to be wet in the bottom indicating the cracks in the concrete may be letting water seep through and wash out the sediment behind the wall. The surge box was full of water so could not observe the sediment build up in the bottom of the box. (DWR Sutter Yard - afreitag)4/14/2016 Deep sink hole above surge box on WS, possibly caused by burrowing, possibly creating conduit for seepage into surge box, which may explain presence of water in box. Recommend pipe be video inspected. Recommend taking another photo in summer to observe possible sediment buildup in box. (DWR UCIP - kfazel)4/2/2015 Pipe has small leak during times of high water. Not sure of the cause. Pumps taken out from the pipe (may be for repairs). Only control board found. LS wing wall minor damage. (DWR Sutter Yard - afreitag)7/2/2014 Same as last inspection. (DWR Sutter Yard - afreitag)12/19/2013 Same as last inspection. (DWR Sutter Yard - afreitag)7/23/2013 Pump motors attached to pipes and running. Think pumps were disconnected during last inspection to keep motors above water for high water season. (DWR Sutter Yard - afreitag)12/11/2012 Pumps taken out from the pipe (may be for repairs). Only control board found. LS wing wall minor damage. (DWR UCIP - pamatya)

FIELD_STRUCT_DESC: 36-inch corrugated metal irrigation pipe through the levee, 20 feet below the crown. Concrete headwall on the landside (LS) with meter. Slide gate on the waterside (WS) end. Two slant pumps on the WS bank discharging into a concrete distribution box at the WS toe. Switch panel on the WS. (Permit No. 2971, 1959 - Sartain). [Additional Reference(s): DWR Levee Log, 2002. USACE Sacramento O&M Manual 136, March 1960 (HLM 12.55)].
FS Date: 8/30/2018 3:41:00 PM

Waterside view: overview
